## 9975 Shipping Container Tipover

March 28, 2008

2008-RL-HNF-0004

Tracking No: 923

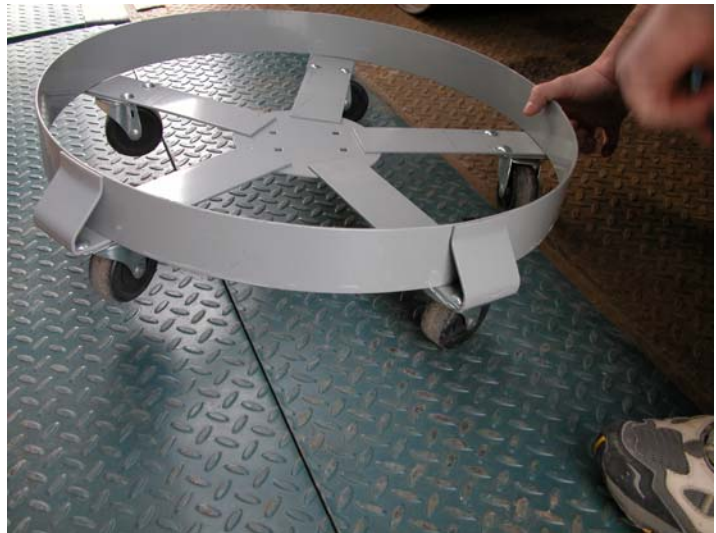
**Analysis:** The 9975 tipped-off the five-wheeled dolly when one of the wheels caught in a gap (1 inch wide by 3/16 inch deep) formed where the docks lift leveler and truck bed connected. If the truck had been backed closer to the dock the gap would have been eliminated.

The lift levelers slight downward curve to the truck bed caused two of the five dolly wheels to lose contact with the surface. This altered the center of gravity of the container and dolly creating instability which contributed to the event.

The dolly is designed for a 55 gallon drum whereas the 9975 is a 35 gallon drum. As such, the 9975 does not fit snugly in the dolly. This allows the 9975 to move around within the dolly ring which may introduce some instability in certain situations. Workers indicated that once the dolly wheel caught in the gap, the 9975 slid within the dolly ring prior to tipping over.

- Use the buddy system when moving large, heavy fissile bearing containers on five-wheeled dollies over rough or pronounced transitional areas.
- Ensure rough transition areas are minimized before moving across them. Inspect these potentially hazardous spots and attempt to mitigate them by making adjustments, such as positioning the process truck, leveling depressions and placing the lift leveler.
